Appendix O

Connecticut Coastal Structures Inventory Study - Phase III

APPENDIX O
WESTPORT QUADRANGLE

RECORDS OF STRUCTURES WITH PHOTOGRAPHS

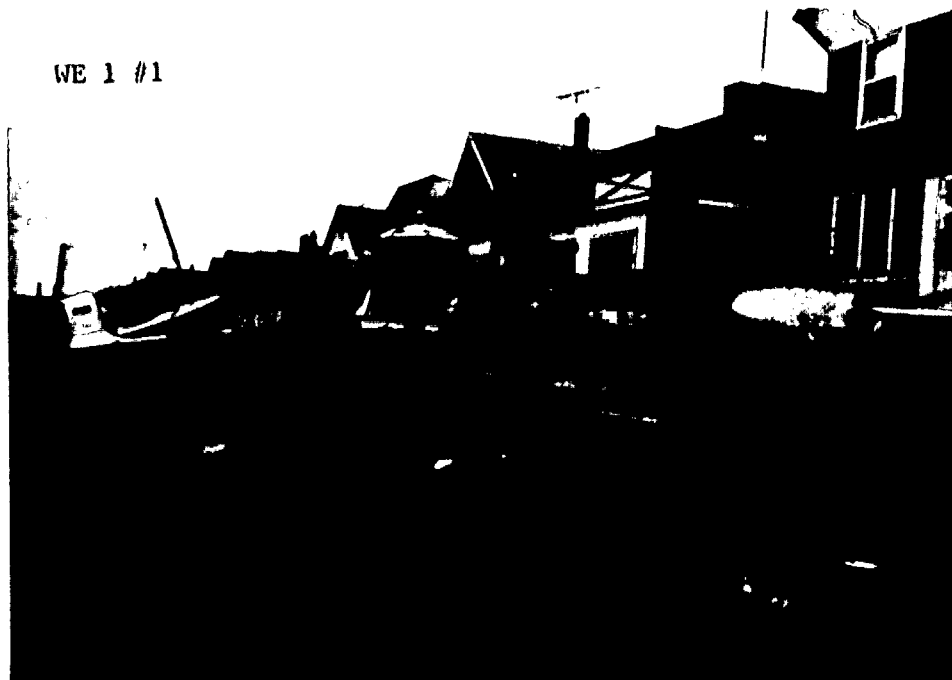
WE 1 #1

TYPE OF STRUCTURE: SEAWALL CONDITION: FAIR
MAIN FUNCTION : SEPARATES LAND AND WATER, PREVENTS EROSION AND FLO
MATERIAL : STELL ON WOOD

L(FT)= 50
W(FT)= 0.5-1
H(FT ABOVE MHW)= 3

#1 ROLL 103 NEG#8 LOOKING EAST
#2
#3
#4
#5

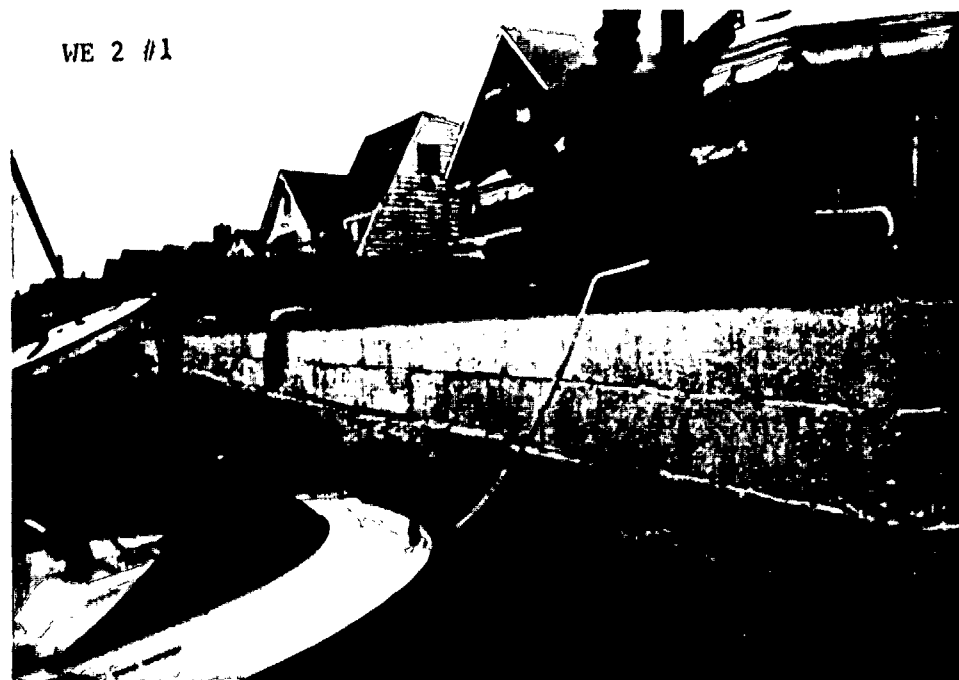
WE 2 #1

TYPE OF STRUCTURE: SEAWALL CONDITION: GOOD
MAIN FUNCTION : SEPARATES LAND AND WATER, PREVENTS EROSION AND FLO
MATERIAL : CEMENT BLOCKS

L(FT)= 60
W(FT)= 0.5
H(FT ABOVE MHW)= 5

#1 ROLL 103 NEG#9 LOOKING WEST
#2
#3
#4
#5

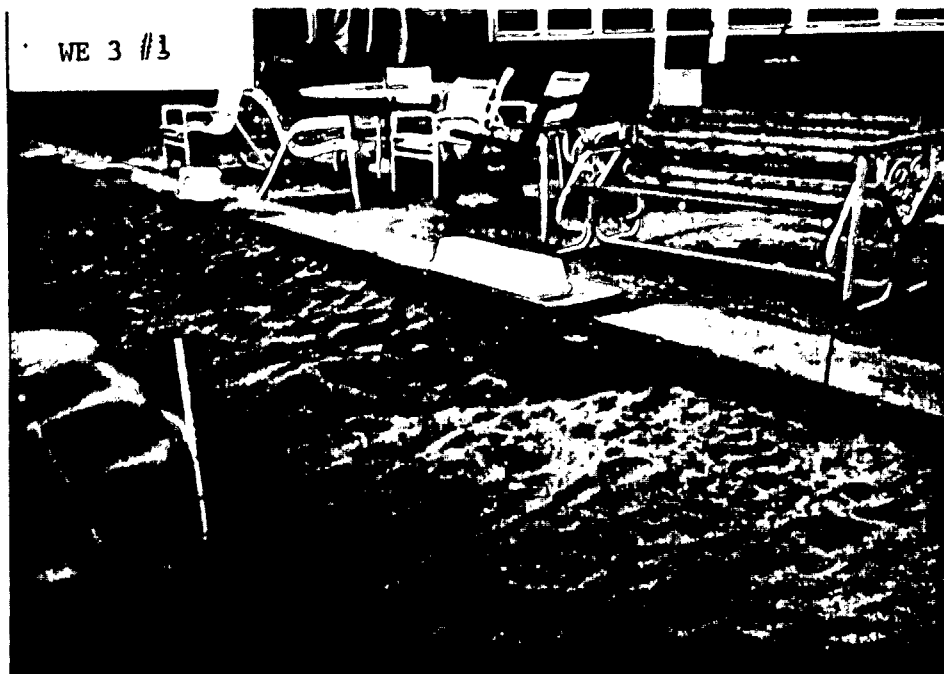
WE 3 #1

TYPE OF STRUCTURE: SEAWALL CONDITION: GOOD
MAIN FUNCTION : SEPARATES LAND AND WATER, PREVENTS EROSION AND FLO
MATERIAL : CONCRETE

#1 ROLL 103 NEG#10 NORTH
#2
#3
#4
#5

BURIED ALMOST COMPLETELY BY SAND

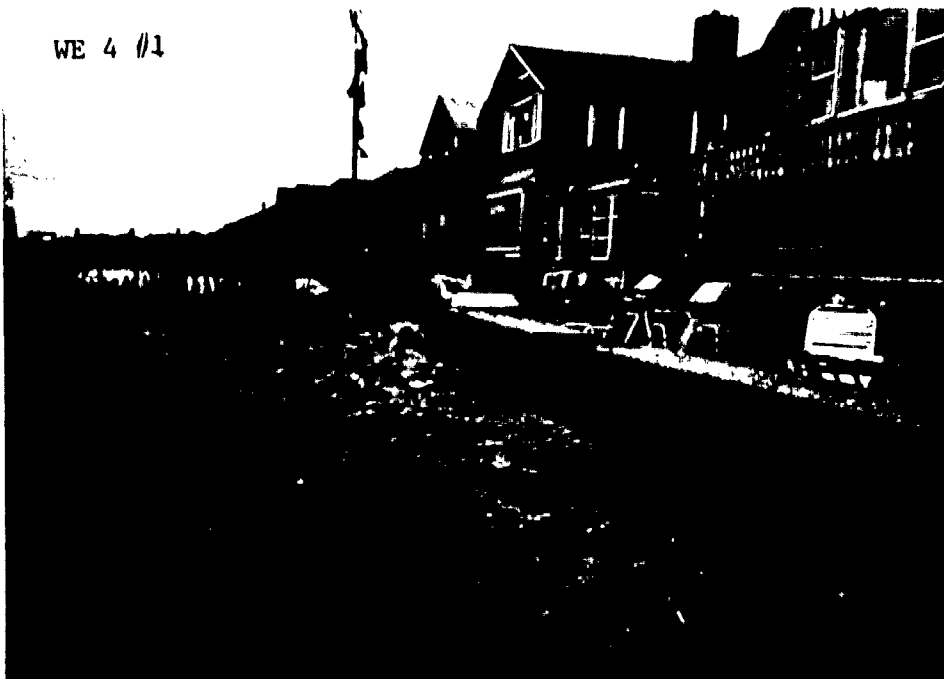
WE 4 #1

TYPE OF STRUCTURE: SEAWALL CONDITION: GOOD
MAIN FUNCTION : SEPARATES LAND AND WATER, PREVENTS EROSION AND FLO
MATERIAL : CONC., CEM. BLOCK

#1 ROLL 103 NEG#11 LOOKING WEST AT THE BEGINNING OF THE WALL
#2 ROLL 103 NEG#12 LOOKING EAST AT THE FAR END OF THE WALL
#3
#4
#5

AT THE BEGINNING SAND ALMOST COVERS THE WALL, AT THE END THE
WALL IS ABOUT 5-6 FT ABOVE THE SAND.

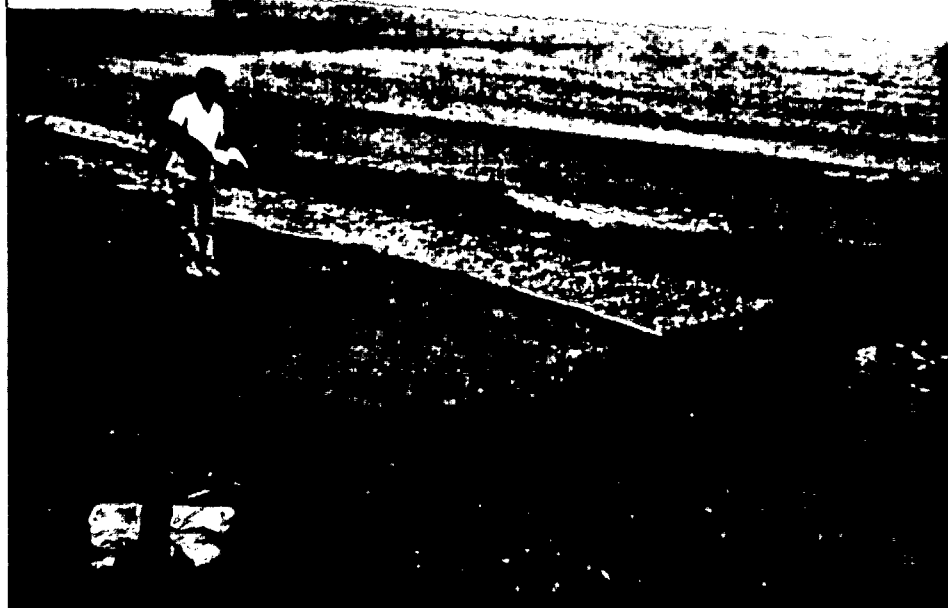
WE 6 #1

TYPE OF STRUCTURE: GROIN CONDITION: POOR
MAIN FUNCTION : TRAPS LITTORAL DRIFT, RETARDS SHORE EROSION
MATERIAL : TIMBER PILE

#1 ROLL 103 NEG#14 LOOKING SOUTHEAST
#2
#3
#4
#5

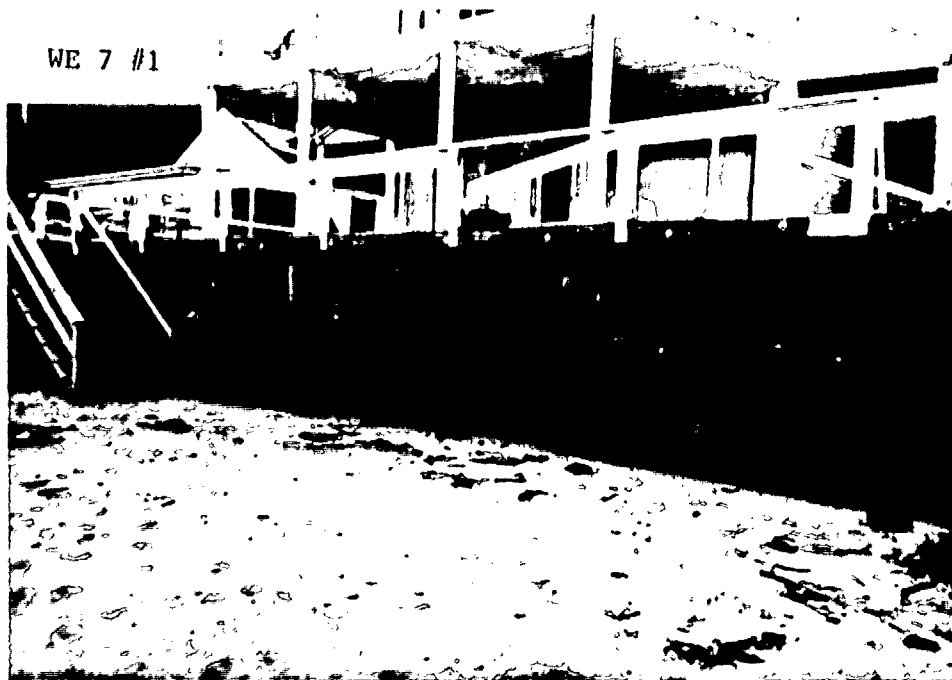
WE 7 #1

TYPE OF STRUCTURE: SEAWALL CONDITION: GOOD
MAIN FUNCTION : SEPARATES LAND AND WATER, PREVENTS EROSION AND FLO
MATERIAL : WOOD

#1 ROLL 103 NEG#15 LOOKING NORTHWEST
#2
#3
#4
#5

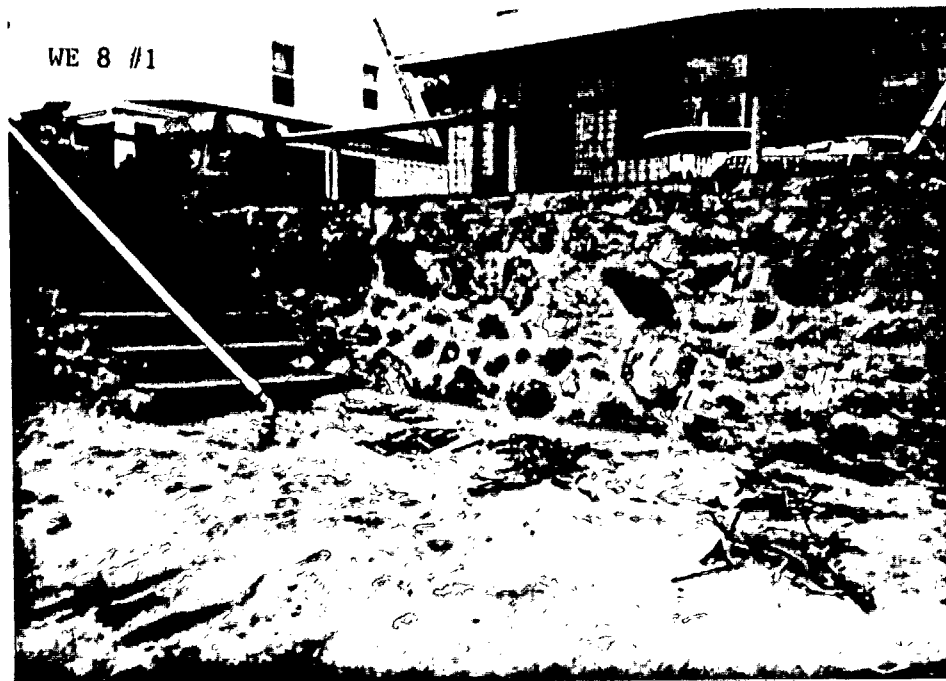
WE 8 #1

TYPE OF STRUCTURE: SEAWALL CONDITION: GOOD
MAIN FUNCTION : SEPARATES LAND AND WATER, PREVENTS EROSION AND FLO
MATERIAL : STONE IN CEMENT

#1 ROLL 103 NEG#16 LOOKING NORTH
#2
#3
#4
#5

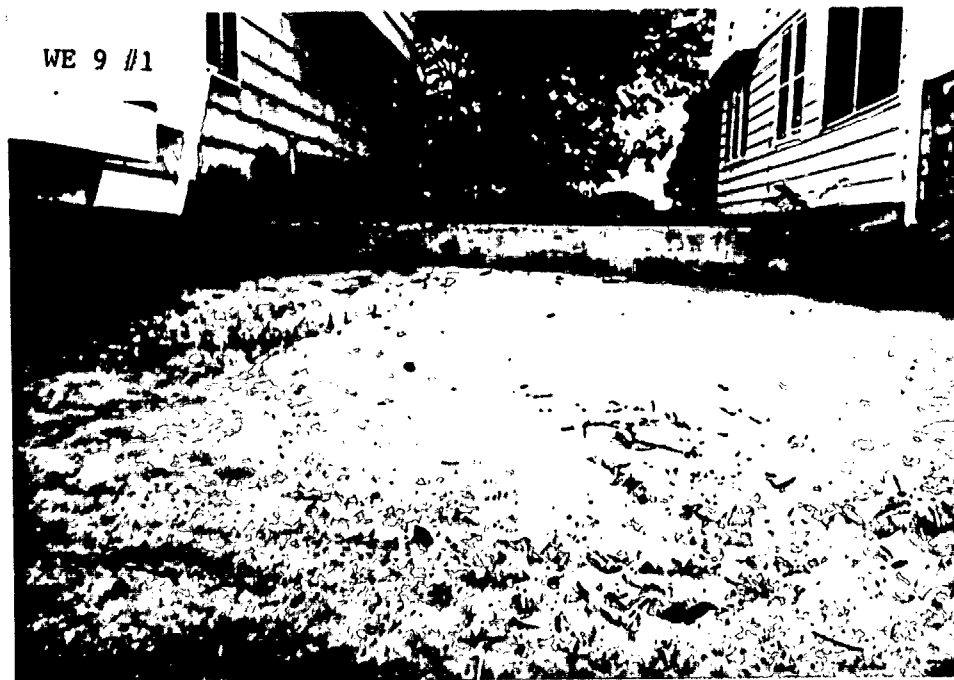
WE 9 #1

TYPE OF STRUCTURE: SEAWALL CONDITION: GOOD
MAIN FUNCTION : SEPARATES LAND AND WATER, PREVENTS EROSION AND FLO
MATERIAL : CONCRETE

#1 ROLL 103 NEG#17 LOOKING NORTH
#2
#3
#4
#5

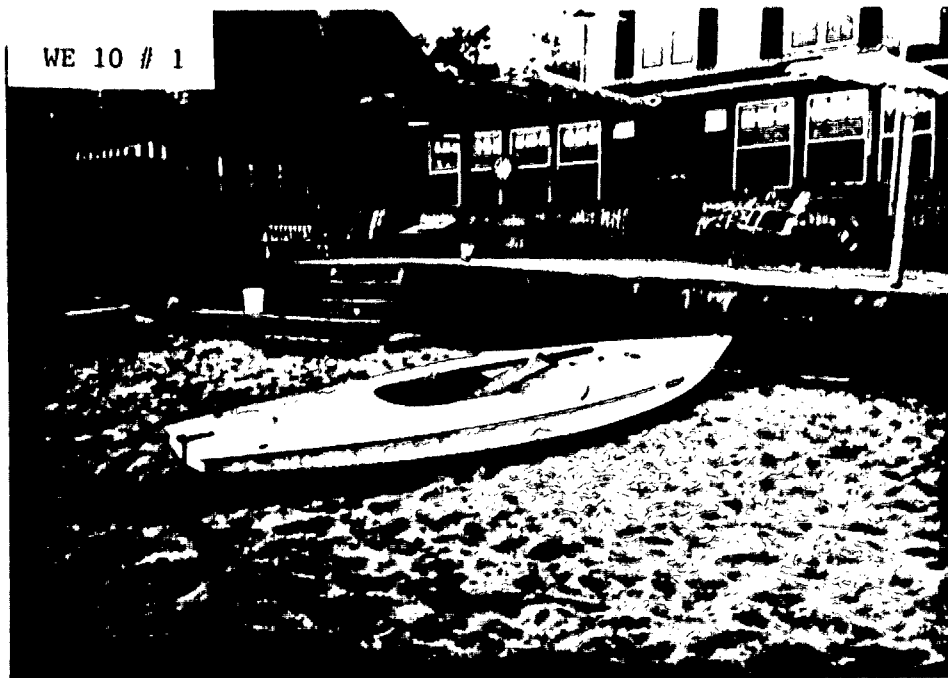
WE 10 # 1

TYPE OF STRUCTURE: SEAWALL CONDITION: FAIR
MAIN FUNCTION : SEPARATES LAND AND WATER, PREVENTS EROSION AND FLOODING
MATERIAL : CONCRETE

#1 ROLL 103 NEG#18 LOOKING NORTHWEST
#2 ROLL 103 NEG#19 LOOKING NORTHEAST
#3
#4
#5

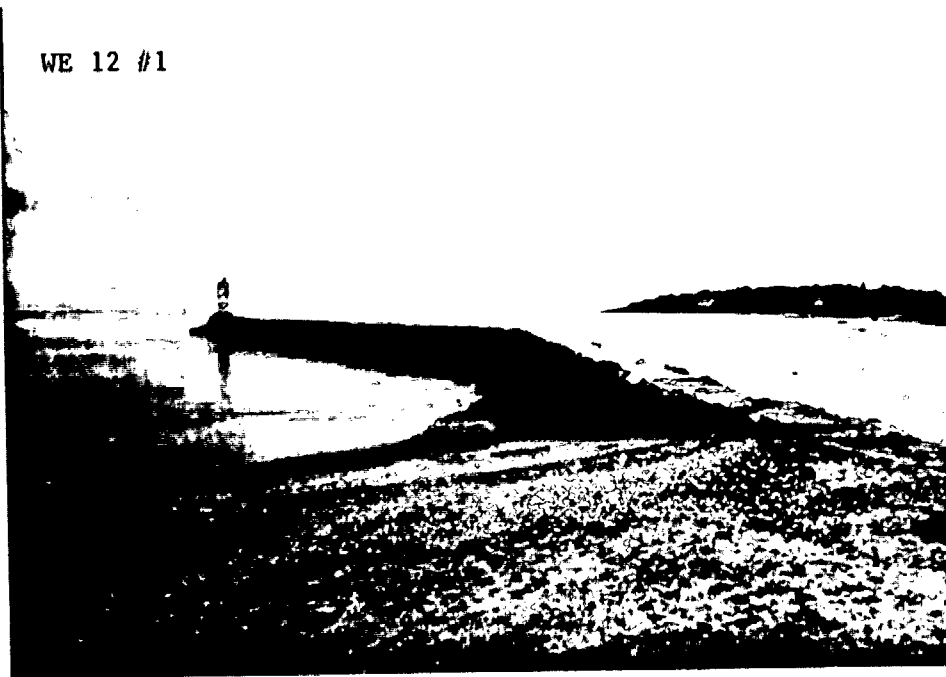
WE 12 #1

TYPE OF STRUCTURE: BREAKWATER CONDITION: GOOD
MAIN FUNCTION : PROTECTS HARBOR/ANCHORAGE BY INTERCEPTING WAVES
MATERIAL : STONE BLOCKS

#1 ROLL 106 NEG#12 LOOKING WEST
#2
#3
#4
#5

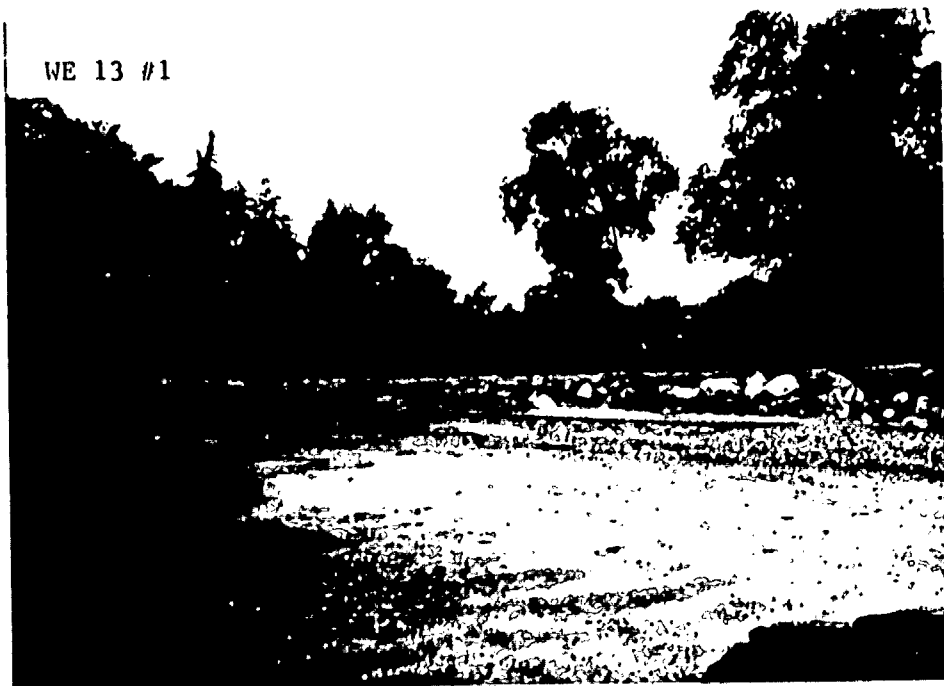
WE 13 #1

TYPE OF STRUCTURE: SEAWALL CONDITION: GOOD
MAIN FUNCTION : SEPARATES LAND AND WATER, PREVENTS EROSION AND FLO
MATERIAL : STONE IN CEMENT

#1 ROLL 106 NEG#13 LOOKING NORTHWEST
#2 ROLL 106 NEG#14 LOOKING WEST
#3 ROLL 106 NEG#15 LOOKING NORTHWEST
#4 ROLL 106 NEG#16 LOOKING NORTHWEST
#5

TOPPED BY A WALK. PARTS OF THE WALL ARE BLOCKED BY LARGE ROCK

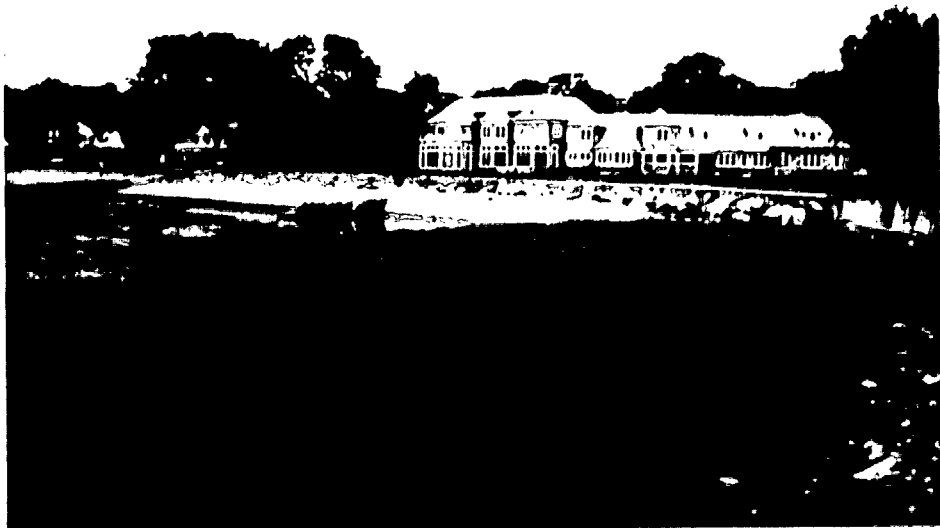
WE 14 #1

TYPE OF STRUCTURE: SEAWALL/RIPRAP CONDITION: GOOD
MAIN FUNCTION : SEPARATES LAND AND WATER, PREVENTS EROSION AND FLO
MATERIAL : CONCRETE

#1 ROLL 106 NEG#17 LOOKING NORTH
#2
#3
#4
#5

EXTRA 1.5 FOOT WIDTH AT THE BOTTOM. PROTECTIVE RIPRAP IN
FRONT OF IT, AND A STONE IN CEMENT WALL 2 FEET HIGH AND
1 FOOT WIDE ON TOP BORDERING LAWNS.

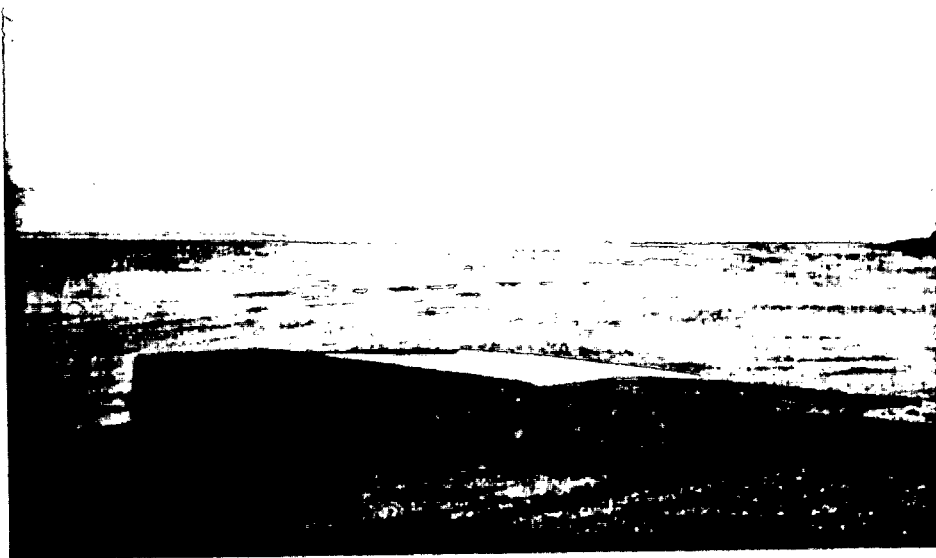
WE 15 #1

TYPE OF STRUCTURE: GROIN CONDITION: GOOD
MAIN FUNCTION : TRAPS LITTORAL DRIFT, RETARDS SHORE EROSION
MATERIAL : CONCRETE

#1 ROLL 106 NEG#18 LOOKING WEST
#2
#3
#4
#5

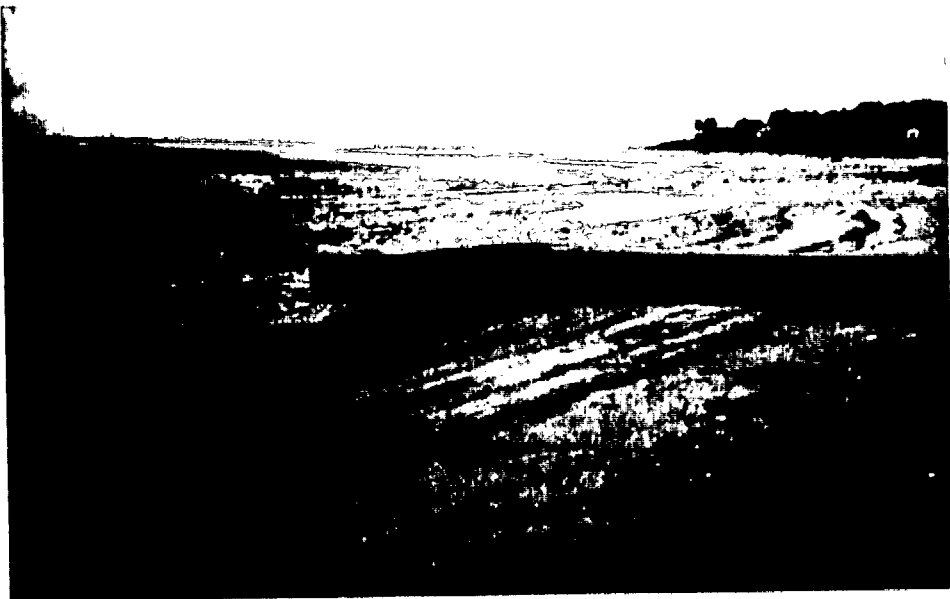
WE 16 #1

TYPE OF STRUCTURE: GROIN CONDITION: GOOD
MAIN FUNCTION : TRAPS LITTORAL DRIFT, RETARDS SHORE EROSION
MATERIAL : CONCRETE

#1 ROLL 106 NEG#19 LOOKING SOUTHWEST
#2
#3
#4
#5

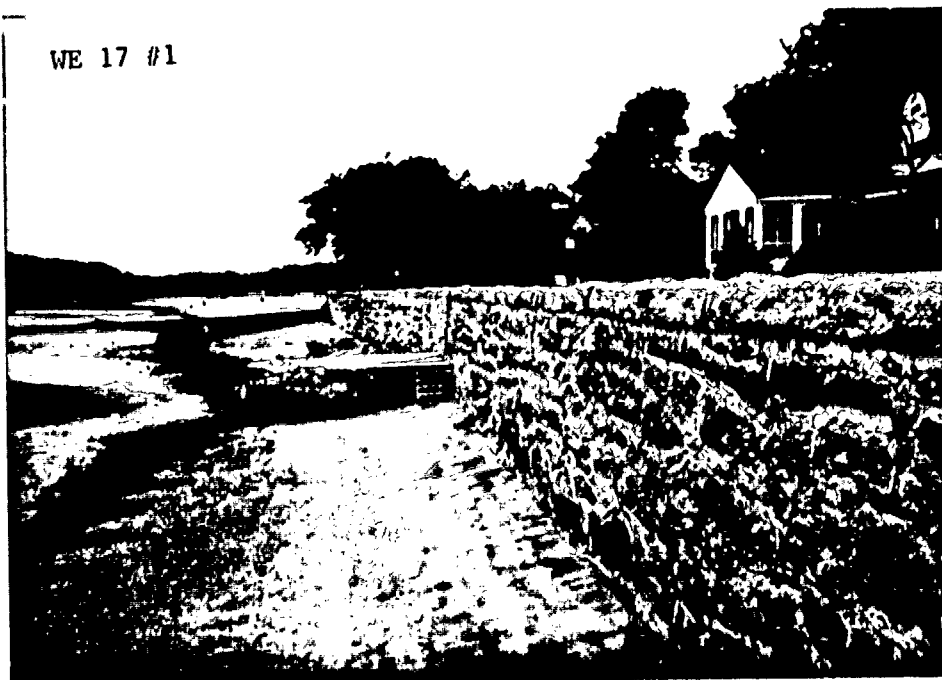
WE 17 #1

TYPE OF STRUCTURE: SEAWALL CONDITION: GOOD
MAIN FUNCTION : SEPARATES LAND AND WATER, PREVENTS EROSION AND FLO
MATERIAL : STONE IN CEMENT

#1 ROLL 106 NEG#20 LOOKING WEST
#2
#3
#4
#5

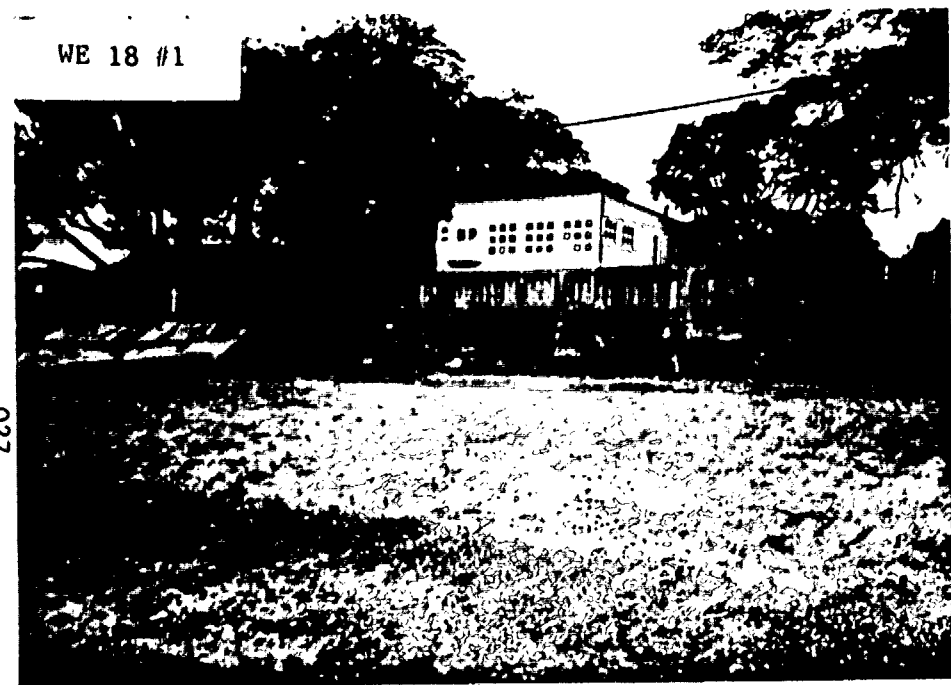
WE 18 #1

TYPE OF STRUCTURE: SEAWALL CONDITION: GOOD
MAIN FUNCTION : SEPARATES LAND AND WATER, PREVENTS EROSION AND FLO
MATERIAL : STONE IN CEMENT

#1 ROLL 106 NEG#21 LOOKING NORTH
#2
#3
#4
#5

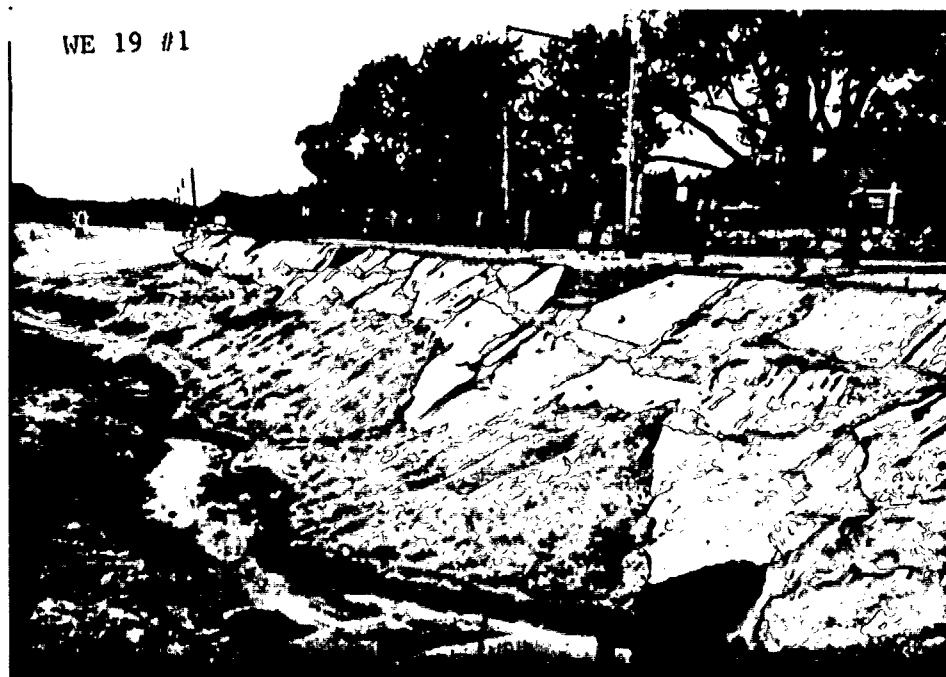
WE 19 #1

TYPE OF STRUCTURE: REVETMENT CONDITION: GOOD
MAIN FUNCTION : FACING ON SLOPE WHICH PREVENTS EROSION
MATERIAL : STONE IN CEMENT

#1 ROLL 106 NEG#22 LOOKING WEST
#2
#3
#4
#5
